Instrowest Pty Ltd

EC 8070

NLN Lube Temp Upgrade

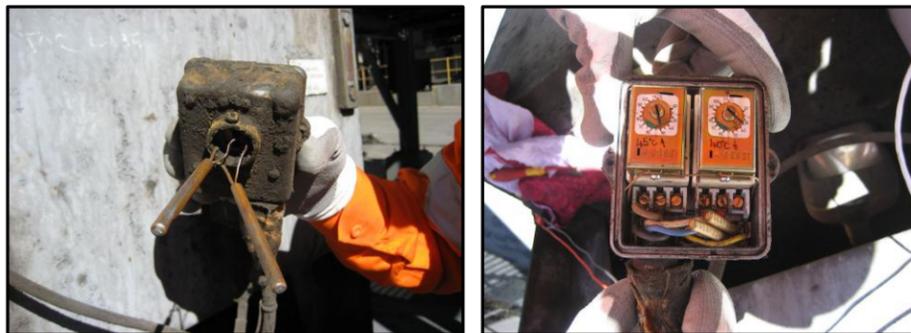
As found, each lube pack incorporated a 'Low' and a 'High' bulb and capillary type thermal switch controlling a lube oil heater and cooling fan respectively through PLC digital inputs. The repeatability of each switch was questionable with non-adjustable hysteresis (dead band) being a contributing factor.

Annual calibration and checks were required to ensure accuracy; this was easily taking between 2 and 4 hours per switch. The lack of a local temperature display and the visual indication of the temperature switch status meant that maintenance personnel were forced to guess the actual temperature when the SAG mill tripped due a lube pack fault.

Above: The old capillary type temperature switches previously installed

The proposal recommended replacing the two bulb and capillary type temperature switches per lube pack with a single RTD and thermowell feeding a local Weidmüller PMX temperature display/controller with configurable relay outputs. The advantages of this setup were numerous and included: local running temperature display, visual indication of switch status and set point, reliability and accuracy of RTD measurement and no dead band in the switching. This resulted in the reduction of labour for maintenance, reducing manning for shutdowns and a more reliable process and quicker fault finding when the plant does go down.
