## Instrowest belt weighing solutions

## Siemens MSI / MMI Weightometer – Western Areas - Cosmic Boy Concentrator

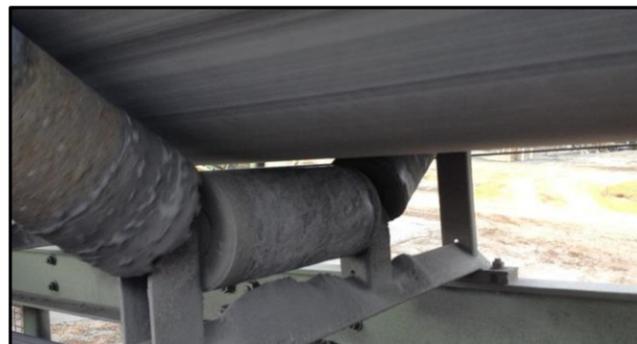
Instrowest technicians found that the curvature in the conveyor frame was allowing the belt to lift from the weigh area on startup and when running empty. This, along with poor idler alignment and incorrect calibration chain data, resulted in poor weightometer performance.

Conveyor lifting off old weigh-area

After discussions with site personnel it was decided that the whole weigh area need to be reinstalled and that the best solution was to start fresh with a new weightometer installation. By raising the weigh area up on the incoming end and installing three lead in and three lead out idler frames with balanced and adjustable rollers, Instrowest was able to ensure that constant contact was maintained across the weigh area.

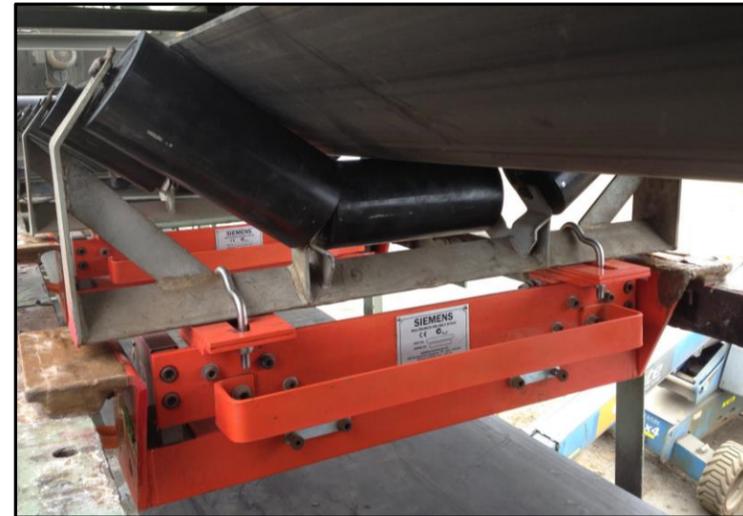
New MMI Frame Installation with balanced and adjustable rollers

The new weightometer chosen was a Siemens MMI installation. This was chosen because:
