Instrowest Case Study

EC 8070

Siemens MSI / MMI Weightometer, accurate & reliable

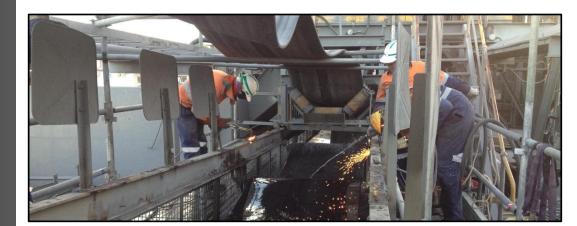
Client Project team removing old frames

Instrowest worked closely with the client's project team to remove the old weightometer and idlers, as well as install two new stringers that provided a flat and level weigh area in which to install the idler and weigh frames. The stringers were custom made by the project team to create the flat area required.
