# Instrowest Case Study

## Ngarda, Yarrie- Tecweigh Installation

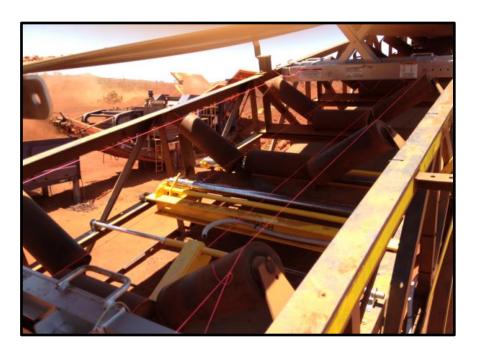
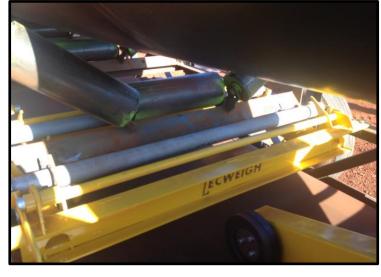
Once on site, Instrowest technicians quickly got to work removing the old unserviceable Schenck system. Once removed, our technicians started work on the new Tecweigh. With the use of "Belt Lifters" Instrowest technicians are able to safely and quickly maneuver frames in and out of the Stacker. Once in, the WY15 frame was secured to the stringers, with the idler frames then evenly spaced over the weigh area. The frames were then shimmed and string lined to ensure maximum accuracy. The Tecweigh integrator was then installed into an existing cabinet. Once installation had finished, zero, span and speed sensor calibrations were performed. Due to the experience Instrowest technicians have in regards to the Tecweigh unit and Weighframe installations, our technicians were able to complete the job within two days, enabling Ngarda to be up and running as soon as possible.

It was decided the best option would be to install a new Tecweigh WY15, chosen for its ease of use, accuracy and dependability. The Tecweigh WY15 comes complete with in-built Calibration weights and a WP20 Integrator. Understanding the financial impact the weightometer failure had on Ngarda, Instrowest worked hard to ensure the job could be completed as quick as possible. Knowing how easily a job can be delayed or held up as the result of missing parts or equipment, the decision was made by Instrowest and Ngarda to have Instrowest Technicians drive from Perth to Port Hedland. By driving to site, Instrowest techs were able to take with them an Instrowest service ute, stocked full of possible spare parts and necessary tooling, making sure any unforeseen problems could be easily taken care of.
