Instrowest Pty Ltd

EC 8070

NLN Lube Temp Upgrade

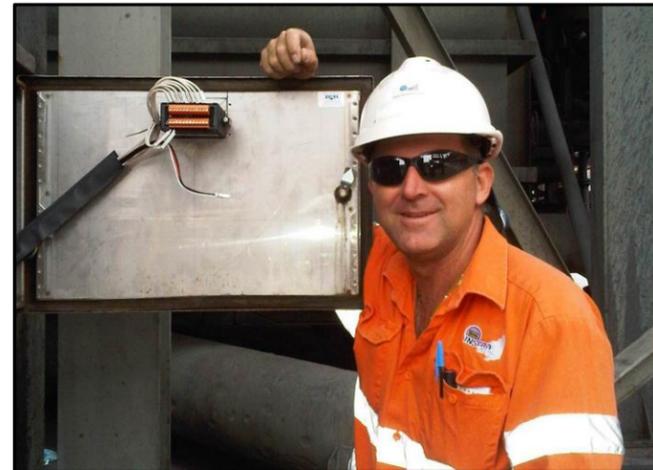
As found, each lube pack incorporated a 'Low' and a 'High' bulb and capillary type thermal switch controlling a lube oil heater and cooling fan respectively through PLC digital inputs. The repeatability of each switch was questionable with non-adjustable hysteresis (dead band) being a contributing factor.

Above: The old capillary type temperature switches previously installed

The proposal recommended replacing the two bulb and capillary type temperature switches per lube pack with a single RTD and thermowell feeding a local Weidmüller PMX temperature display/controller with configurable relay outputs. The advantages of this setup were numerous and included: local running temperature display, visual indication of switch status and set point, reliability and accuracy of RTD measurement and no dead band in the switching. This resulted in the reduction of labour for maintenance, reducing manning for shutdowns and a more reliable process and quicker fault finding when the plant does go down.
