Instrowest Case Study

Marvel Loch Water Addition Automation Upgrade

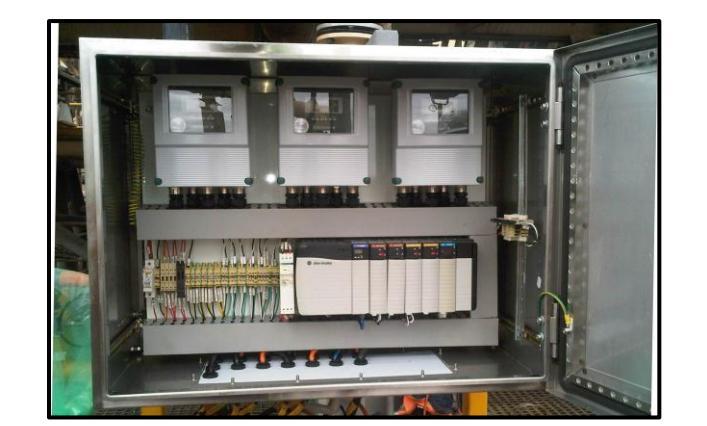
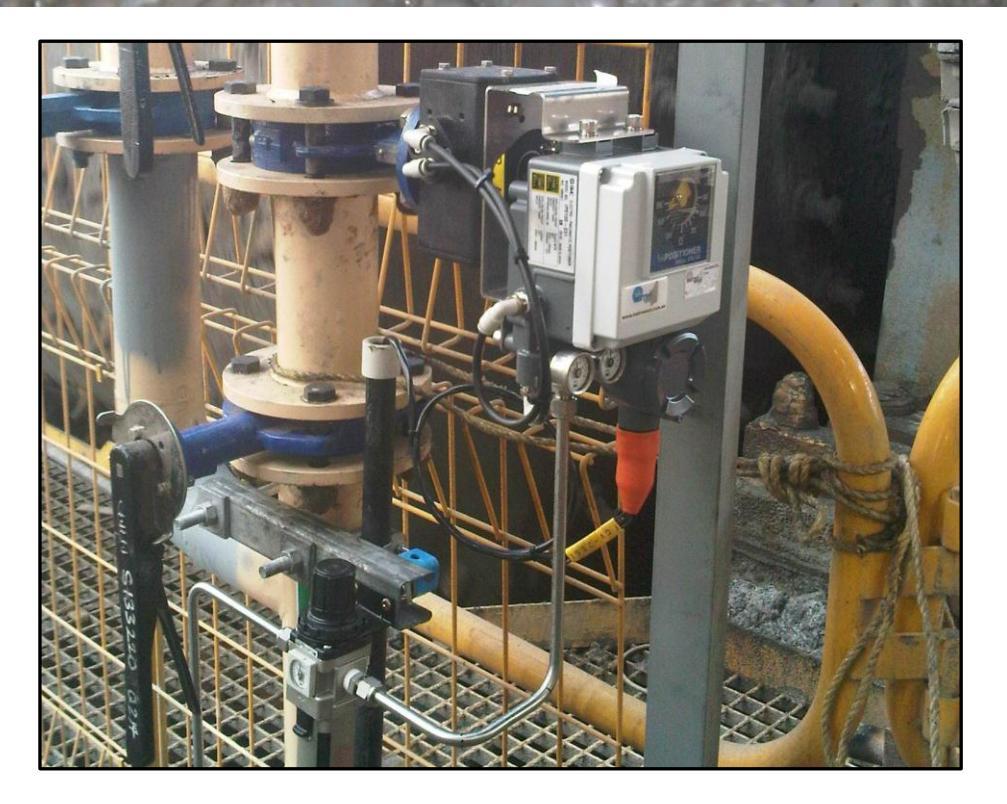
Instrowest worked with our client to design the pipework and addition points; all pipework was manufactured by one of site's preferred local contractors.

In April 2011, Instrowest supplied, installed and commissioned four water addition points. They consisted of Yokogawa AXF dual frequency flow meters, Butterfly Valves (controlled by SMC IP6100 positioners) with filter regulators and Swagelok hard tubing for pneumatic supplies. These addition points were:

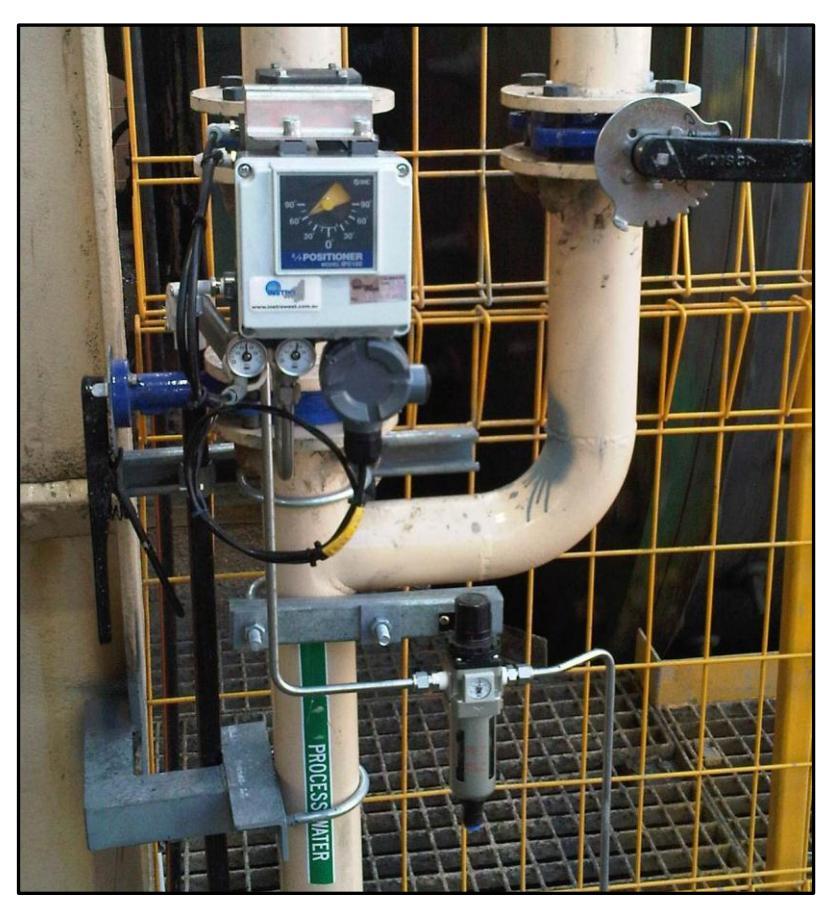
The end result was vastly improved process control within the grinding circuit and very minimal density change during a Knelson flushing cycle. The overall response from site was very positive and they have had no issues with the installation to date.
